Critical Infrastructure Information Notice- CIIN-08-291-01

Possible Counterfeit Cisco Routers

Product Anomaly Inspection: Cisco 2600 Router Series: (2610XM, 2611XM, 2620XM, 2621XM)

Product Anomaly Inspection: Cisco 1721 Modular Router

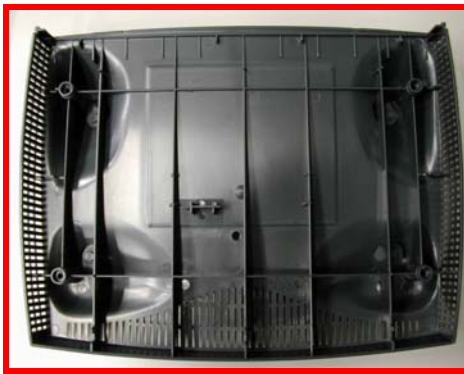
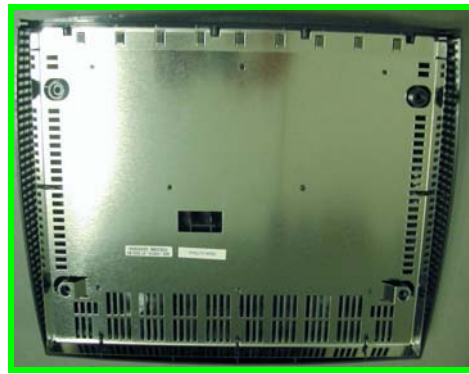
Description: The Cisco 1721 Router has metal Radio Frequency Interference (RFI) mitigation screens in the top and bottom halves of the chassis shell. The following illustrations depict compliant and non-complaint Cisco 1720 chassis shells.

Non-compliant 1721 chassis

Compliant 1721 chassis

Figure 4. Compliant Cisco 1721 router has metal RFI shielding.

Action: Divert Cisco 1721 product that has no metal RFI screens in the top and bottom of the chassis.

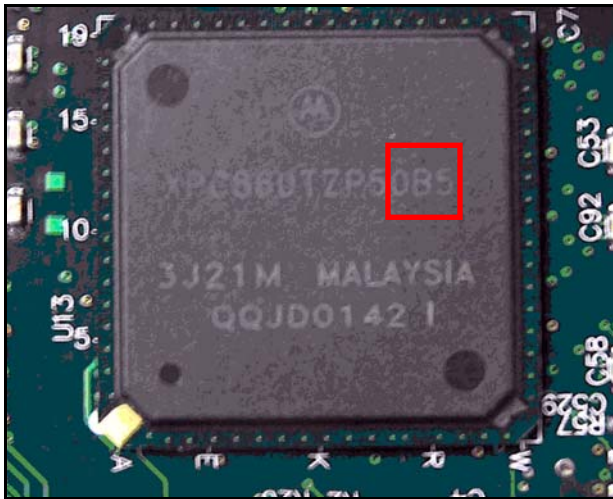
Description: The design for the Cisco 1721 specifies a particular Motorola processor at position **U13** of the PCB, with part number **XPC860PZP50D4**. Certain non-compliant units have a similar processor with part number, with the letter **B** in the next to last position. Only a version **D** chip is correct. A unit that uses version ‘B’ of the chip is non-compliant.

Figure 5. 1721: Non-compliant version ‘B’ Motorola processor.

Action: Examine the Motorola processor at position U13 of the PCB. Divert Cisco 1721 product with a “B” version of this as potential counterfeit.

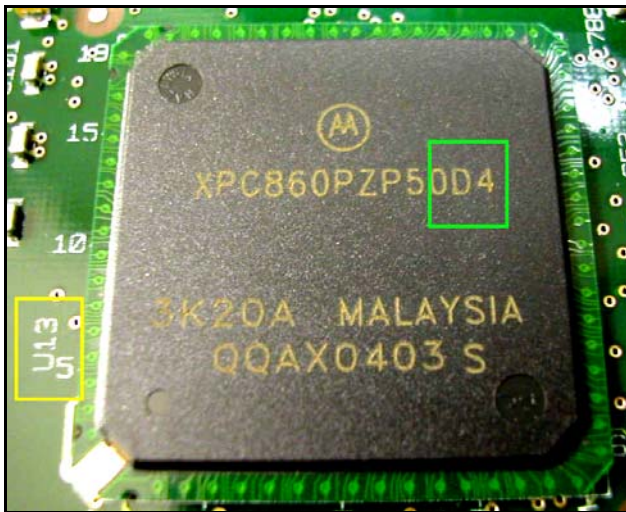
Figure 6. 1721: Compliant Motorola processor, with “D” revision.
